About Terminal Connection “Fretting”

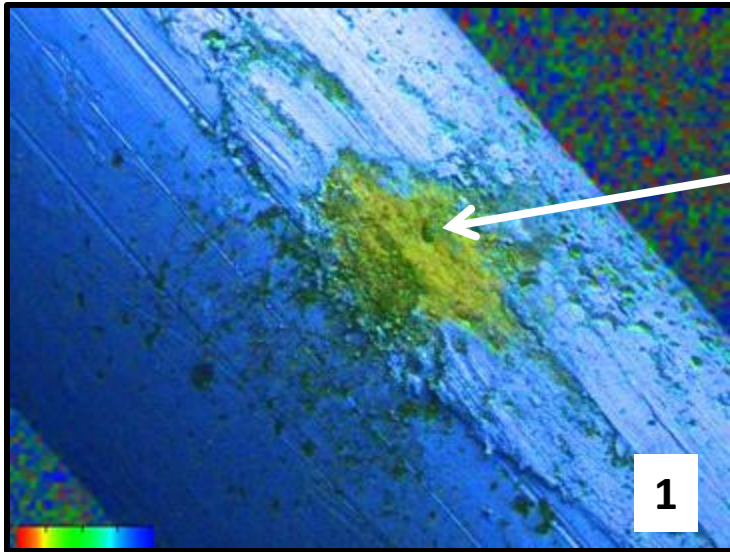
Fretting corrosion is a buildup of insulating oxidized debris (nonconductive material) caused by micro motion between two contact surfaces. (Fig 1)

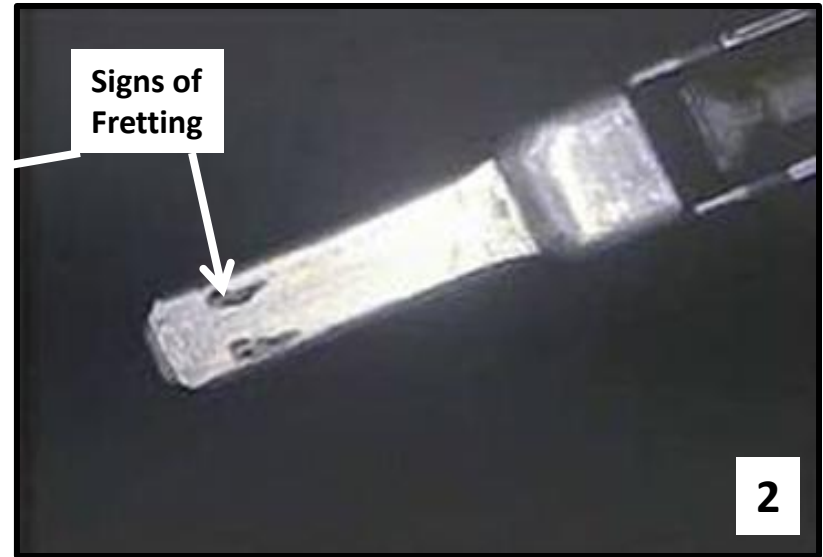
Fretting usually appears as: small, dark smudges on electrical terminals, or smudges at the locations of electrical contact (Fig. 2). In less severe cases, it may require a magnifying glass to identify a fretting condition.

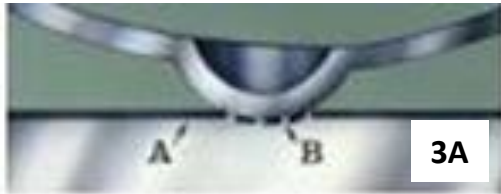
A. Tin - clean (free of any corrosion) (Fig. 3, A)

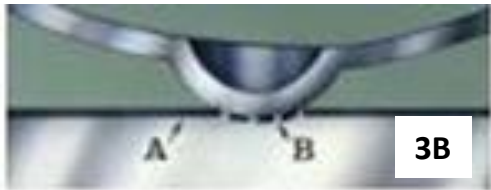
B. A connection is made through the cracks in the tin-oxide layer, making a stable connection. (Fig. 3, B)

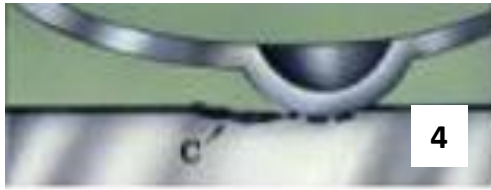
C. When the terminal vibrates or moves a section of the clean tin is exposed to the air and it quickly forms an insulating tin-oxide film. (Fig. 4)
